Proof of Performance

PETROTAC EP PREMIUM 20B ON SHOVELS

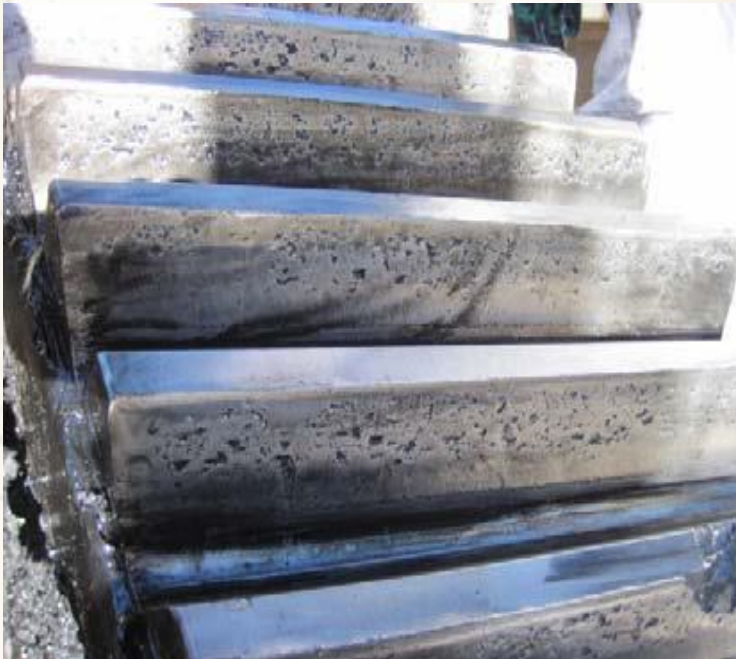
Shovel # 9

Gearing Damage Present

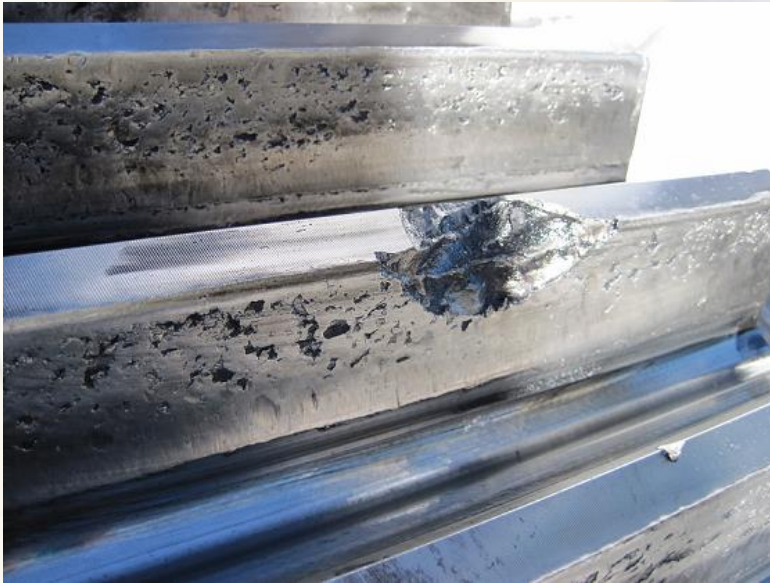
Shovel # 9

Date: June 2012
Operating hours: 12,100 hours
Status: Pitting over 100% of gear teeth, 32 teeth broken!

The shovels continued working without further modification to the condition shown above using our Petrotac EP Premium 20B. The condition of the gears was continuously monitored and the gear change was able to be postponed due to the performance of the Petrotac EP Premium 20B.

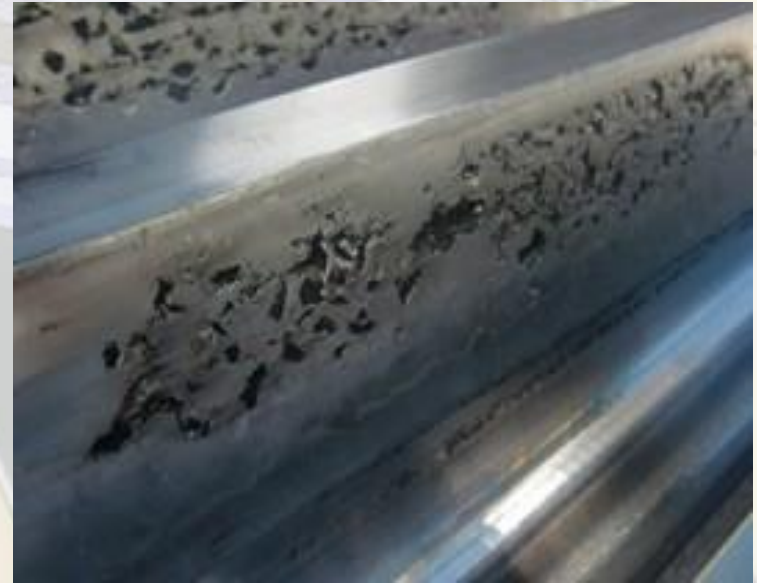
Shovel # 10

Date: August 2012
Operating hours: 9,300 hours
Status: Pitting over 100% of gear teeth

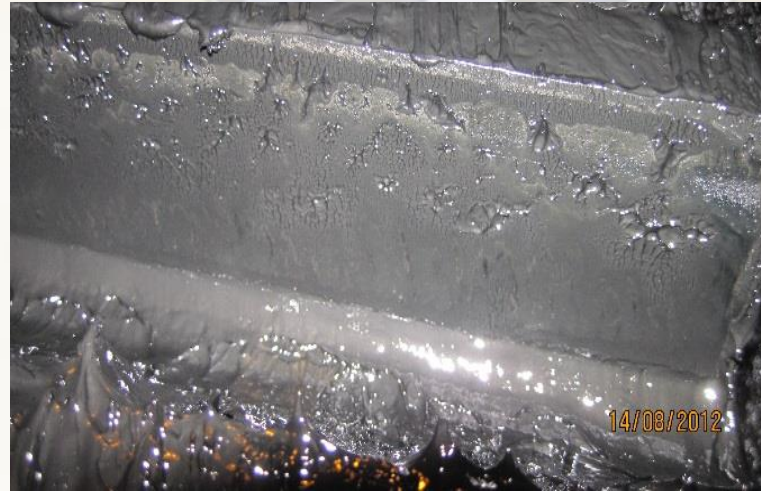
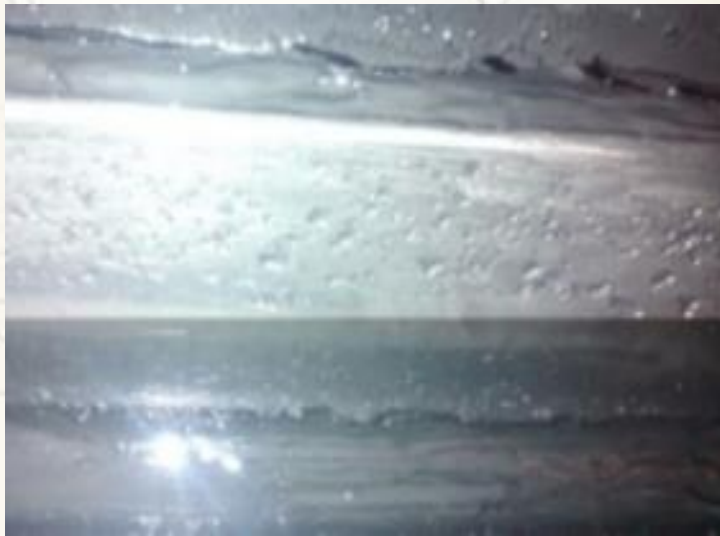
Shovel #9

FINAL INSPECTION FEBRUARY 2015

The damage did not progress significantly further after the switch to Petrotac EP Premium 20B. The mine was completely satisfied with the product. The other components, swing gear, stick and saddle block bushing also surpassed OEM time between overhaul.
