### Hi Temp 242 in the Steel Industry Proof of Performance

- Customer: Minera steel
- Segment: Steel-Pellet plant
- O.E.M.:URALMASH-Russia
- Capacity:0.6mn T
- Length of furnace:45.4 m
- Pump model and ratio: Fireball 300-50:1
- Model of distributors and numbers:
  Graco DL LS 6-6 Series (1.5cc/stroke)
- No of Injector points: 128 (104-Longitudinal seals+24-Side plates)
- OEM recommendation :Lithium EP2 grease

Application: Indurating Furnace Equipment: Uralmash Furnace Lubricant: Petron Hi Temp 242

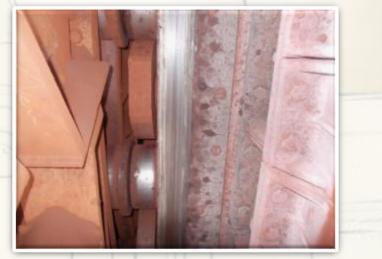
### **Longitudinal Seal**

- 1) Petron Hi Temp 242 is being used from furnace commissioning
- 2) Excellent Lubricant film visible on face of side plate and seal bar.
- 3) Consumption of Hi Temp 242 steady at approximately 2 barrels/month
